BEAR GAP NO. 2

PHASE I INSPECTION REPORT

NATIONAL DAM INSPECTION PROGRAM.

Bear Gap Number 2 (NDS PA-816),
Susquehanna River Basin, Northumberland
and Columbia Counties, Commonwealth of
Pennsylvania. Phase I Inspection Report.

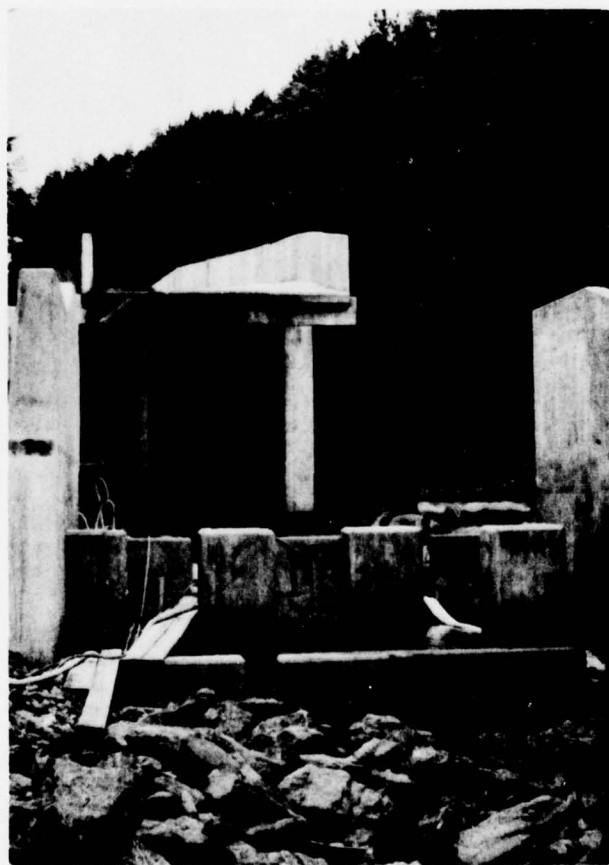
Spillway
Looking Upstream
